# Chip Errata for the i.MX RT1020

This document details the silicon errata known at the time of publication for the i.MX RT1020 multimedia crossover processors.

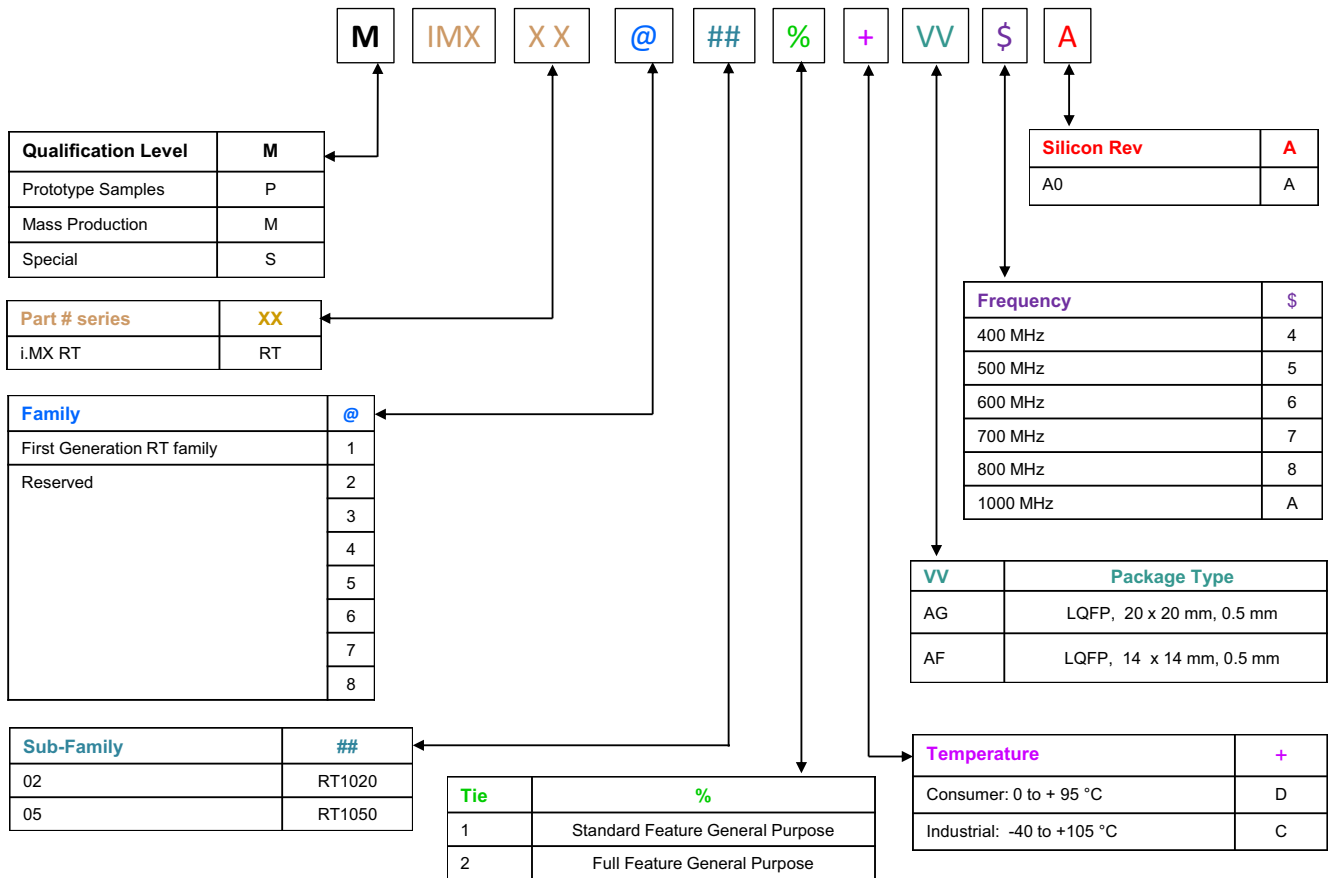
Figure 1. Revision Level to Part Marking Cross-Reference

Figure 1 provides a cross-reference to match the revision code to the revision level marked on the device.
