# Chip Errata for the i.MX 6SLL

This document details the silicon errata known at the time of publication for the i.MX 6SLL multimedia applications processors.

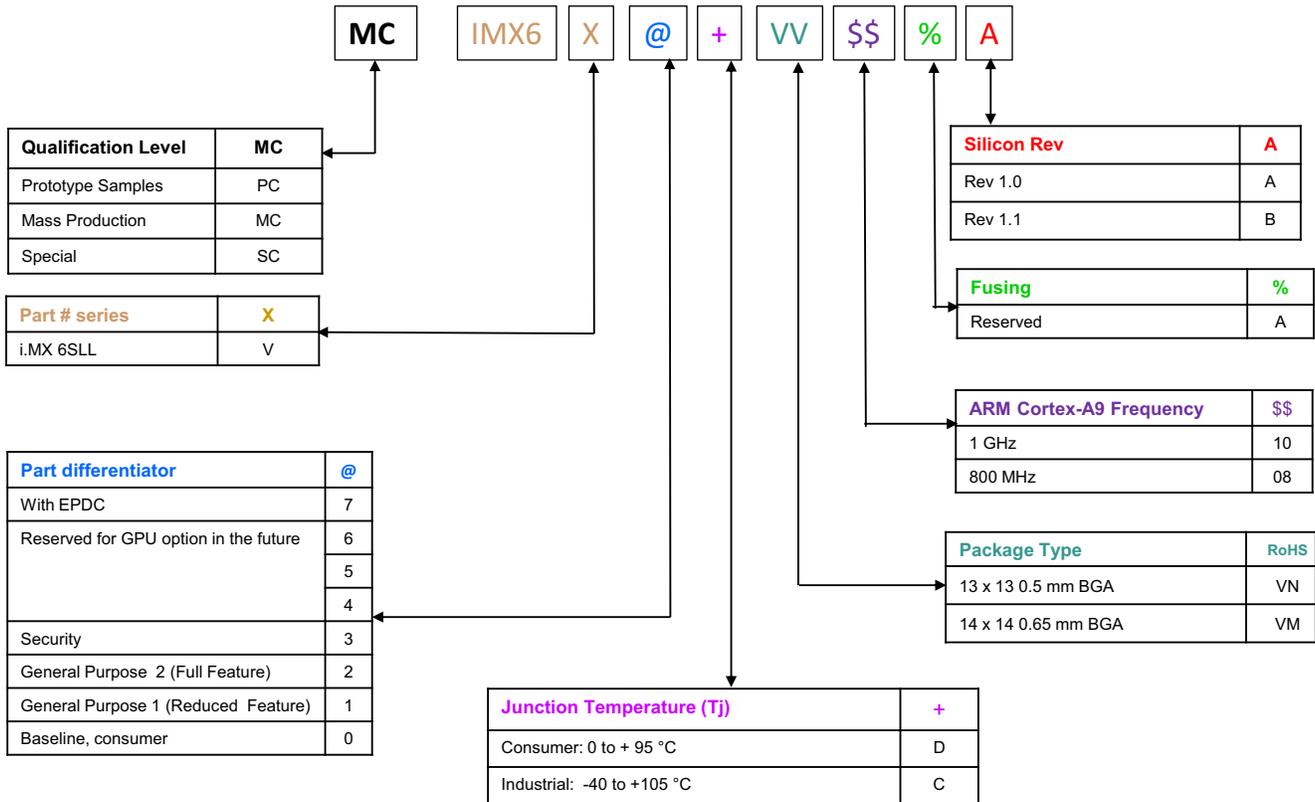
Figure 1. Revision Level to Part Marking Cross-Reference

Figure 1 provides a cross-reference to match the revision code to the revision level marked on the device.
